# Community Preservation Fund Water Quality Improvement

## Cove Hollow Stormwater Pipe End of Pipe Treatment Constructed Wetland

October 19, 2022

Mellissa Winslow  
Town of East Hampton – Natural Resources Department

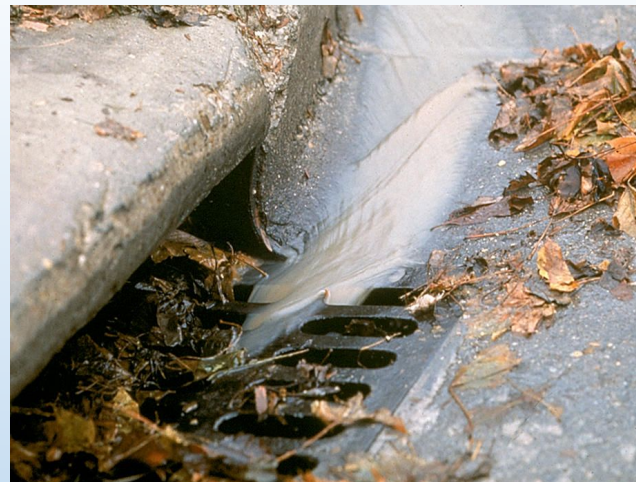
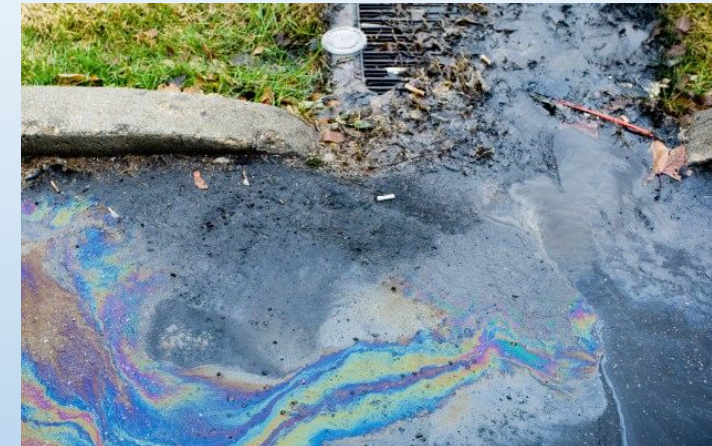
# Non-Point Source Pollution

- Sources of pollution that are diffused, without one single point of origin
- Runoff from rainfall or snow melt that carries pollutants into waterways
- Stormwater Runoff
  - Overland Runoff
  - Stormwater conveyances
  - Direct discharge to waterbody
  - Increased by impervious surfaces

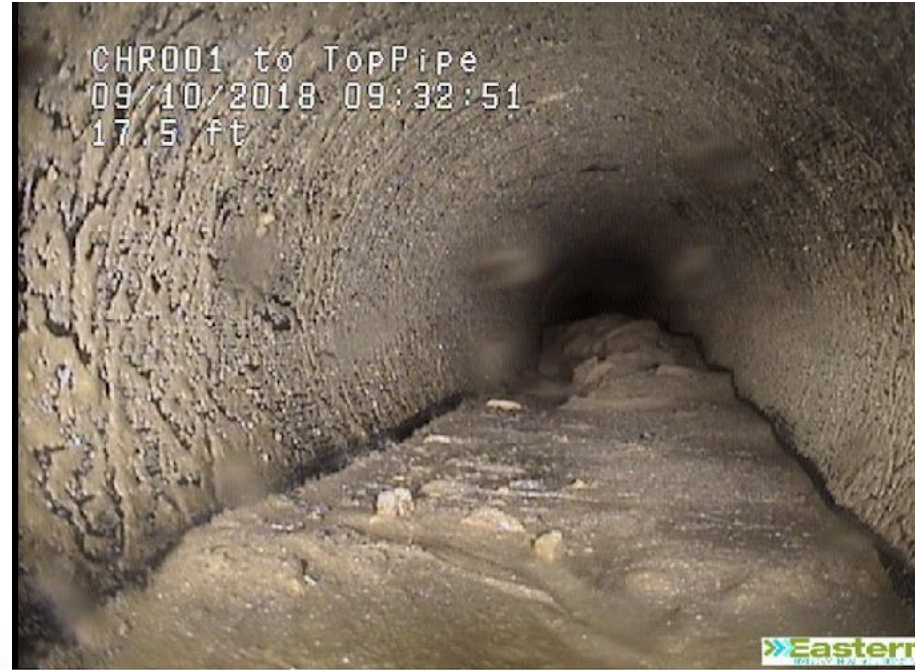
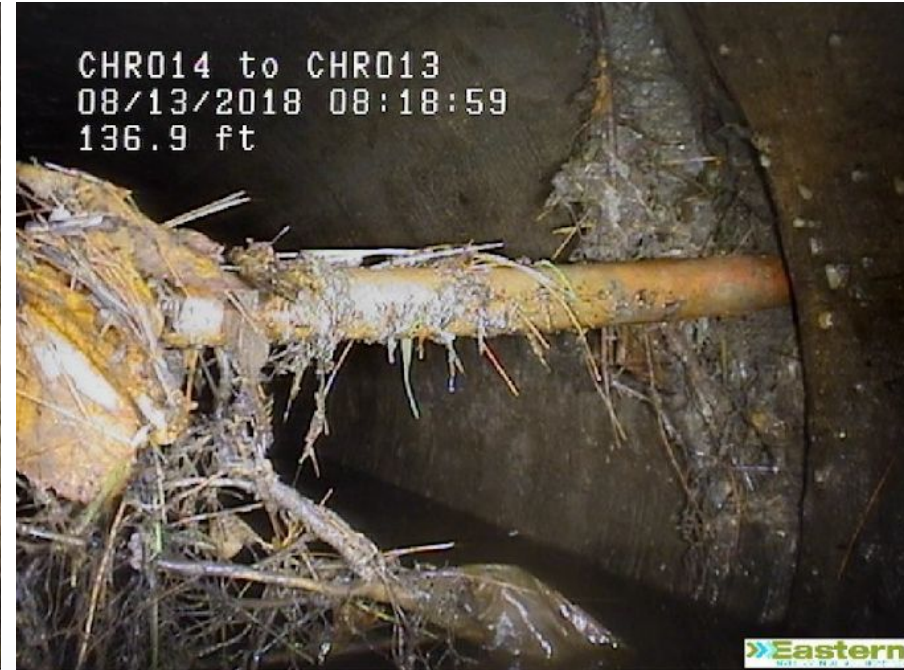
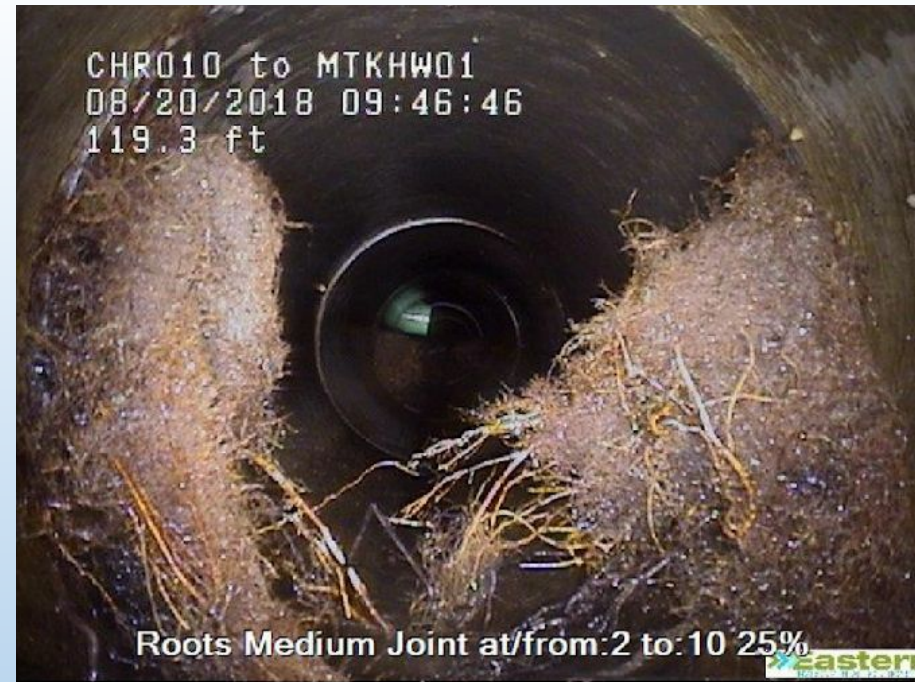
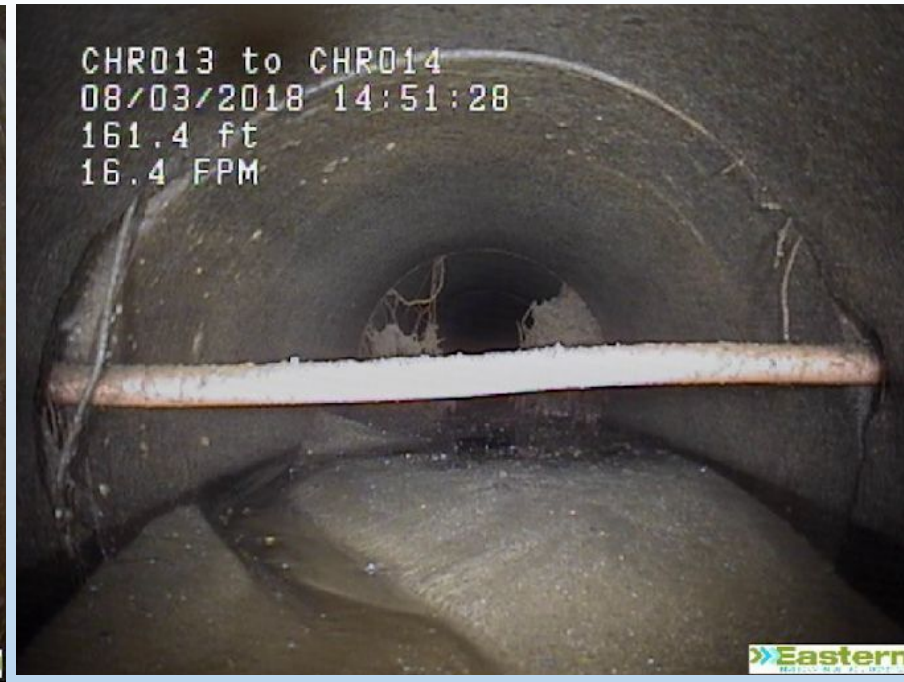
# Observed Storm Pipe Obstructions

- Several locations where tree roots and utility lines breach the pipe
- One catch basin on corner of NY 27/Cove Hollow Road badly damaged and loose gravel has migrated into the basin and the pipe
- Defective patch at the top of the exposed pipe south of Georgica Rd
- Inconsistent materials used for repairs/construction
- Fine deposits found settling along the bottom of the pipe
- Ponding following storm events in several areas
  - Minor ponding from poorly graded or rutted road shoulders
  - Substantial ponding observed in several areas where no drainage structures currently exist or high-water table, poor soils or unmaintained structures not functional
- Several catch basins along the drainage pipe network not at grade and are thus non-functional and make maintenance difficult

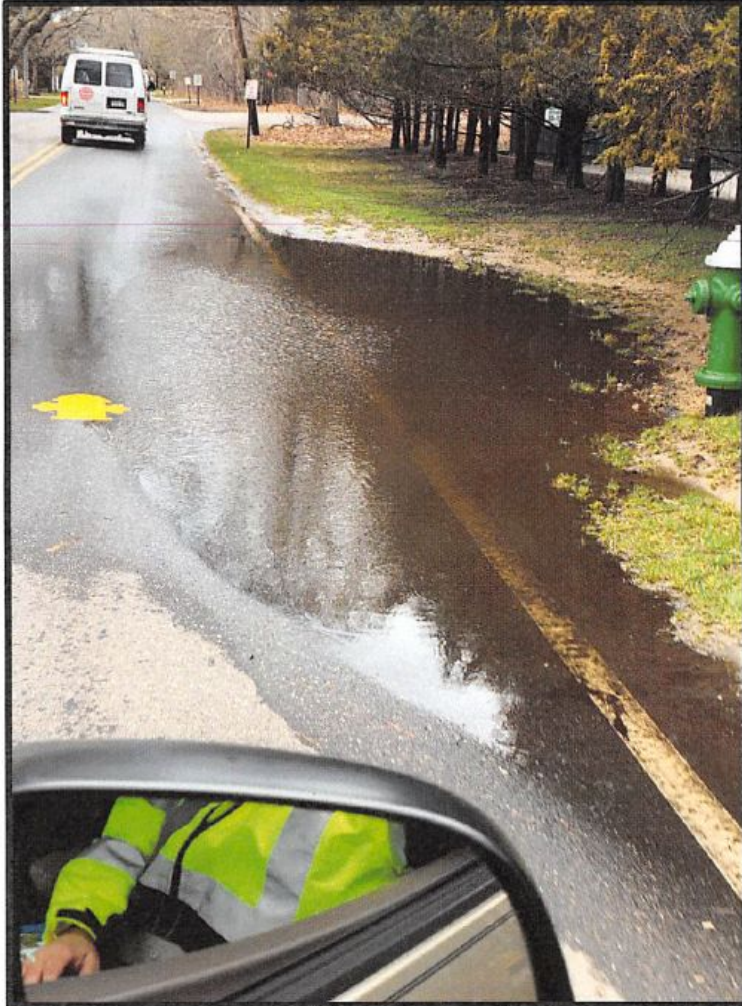
# Examples from Drainage Assessment - Ponding

**Northbound #16**  
East side of Cove Hollow Road  
North of Montauk Highway

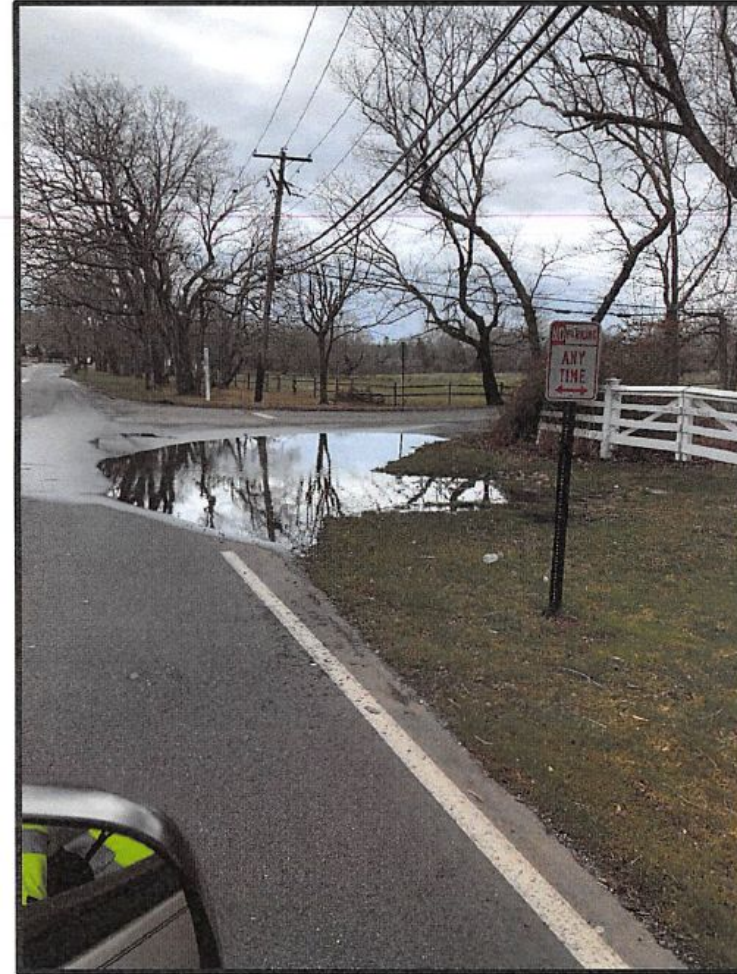
**Southbound #18**  
West side of Cove Hollow Road  
At Buckskill Road

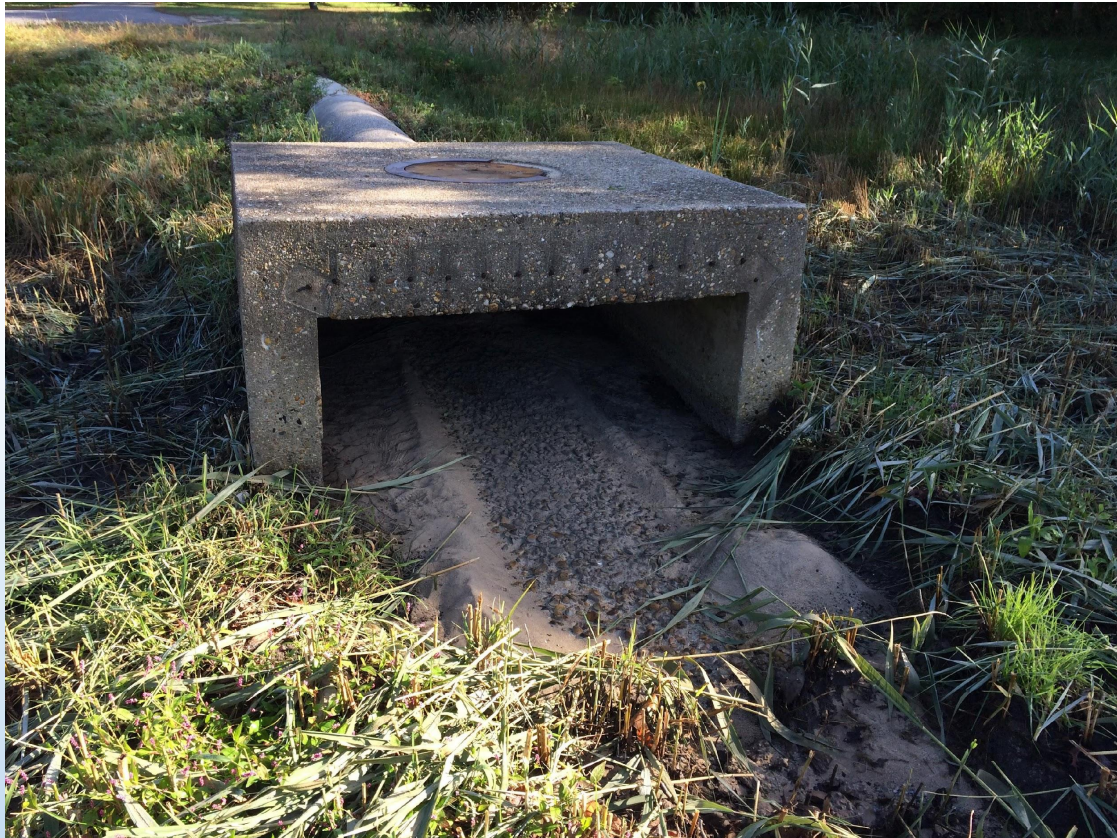
# Cove Hollow Pipe Outlet

Dry Conditions – Low Pond Levels

- Background:
  - Designed and constructed in the 1930's to alleviate flooding from farmland runoff
  - 7,298 linear feet, gravity flow pipe
  - Runs from the railroad trestle at northern end of Cove Hollow Road to the outlet at Georgica Cove
  - When Georgica pond water level is high, the pipe end becomes submerged, and the pond backs up into the pipe
  - Georgica pond affected by algae blooms due to excess N and P impacting water quality
- Project included in the Town of East Hampton Water Quality Improvement Plan

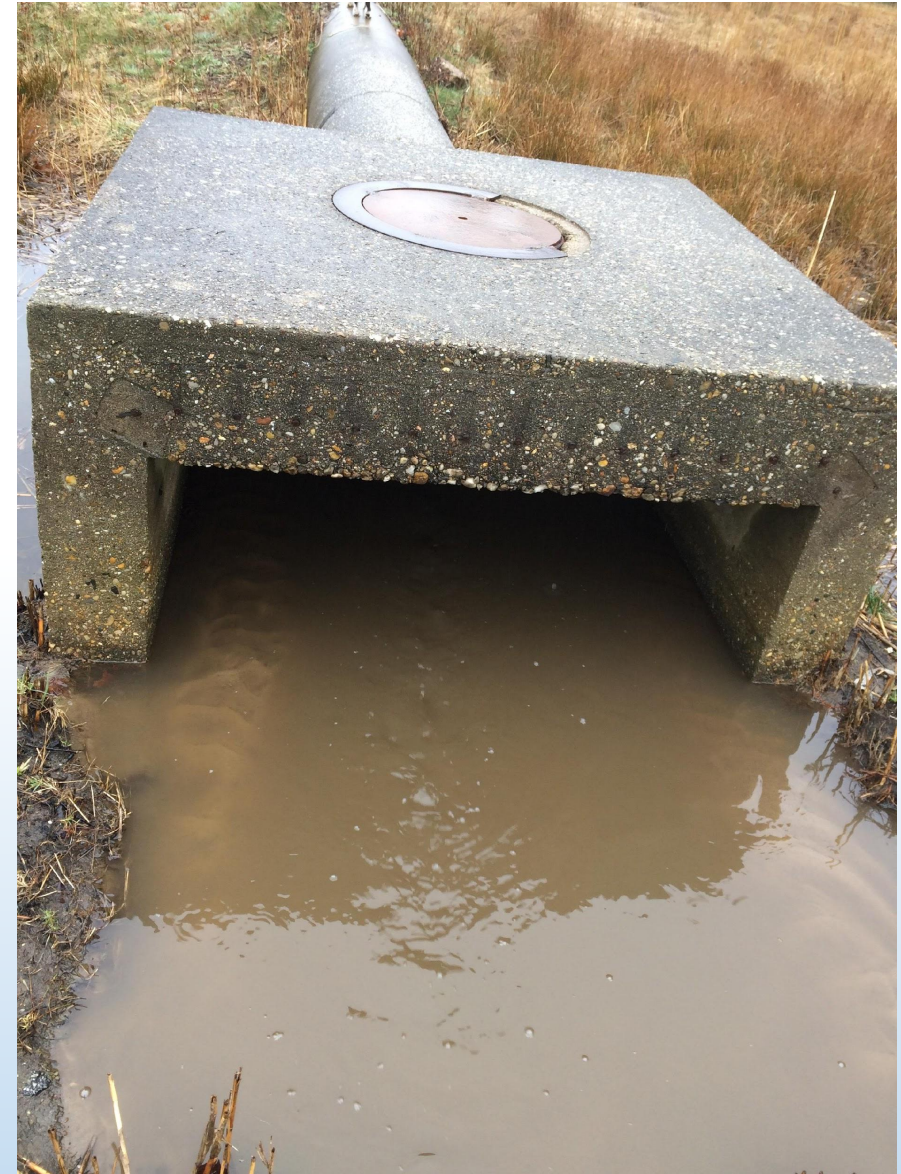
Wet Conditions – Elevated Pond Levels

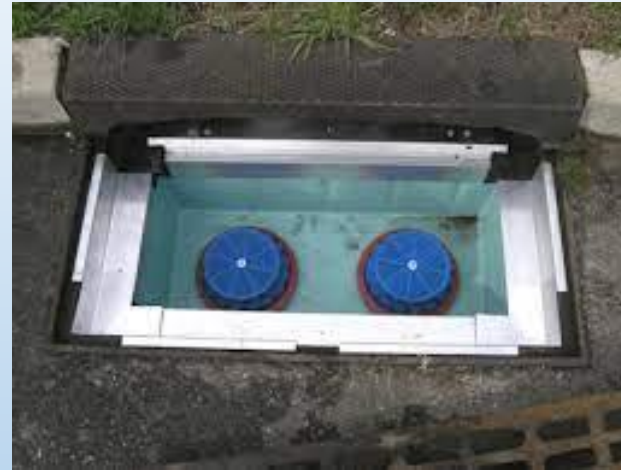
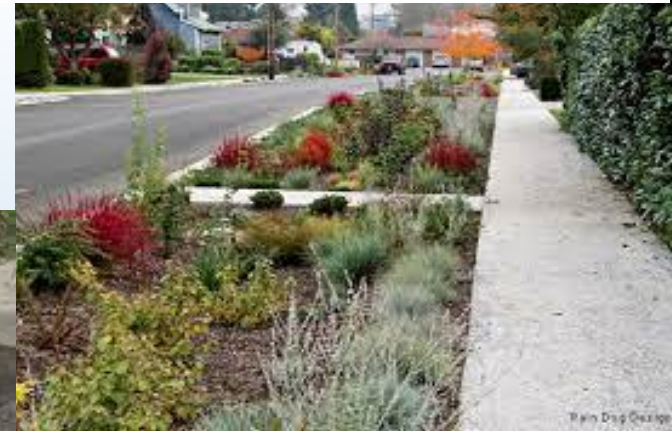
# Goals and Treatment

- Reduce volume of water entering the Cove Hollow Pipe along route to Georgica Pond
  - Capture water before entering pipe inlets
    - Increase number of drywells
    - Install natural, vegetated treatment in upland
- Improve the quality of water entering Georgica Pond from the Cove Hollow Pipe
  - Treat water entering catchbasins using inlet filters to remove pollutants
  - Incorporate

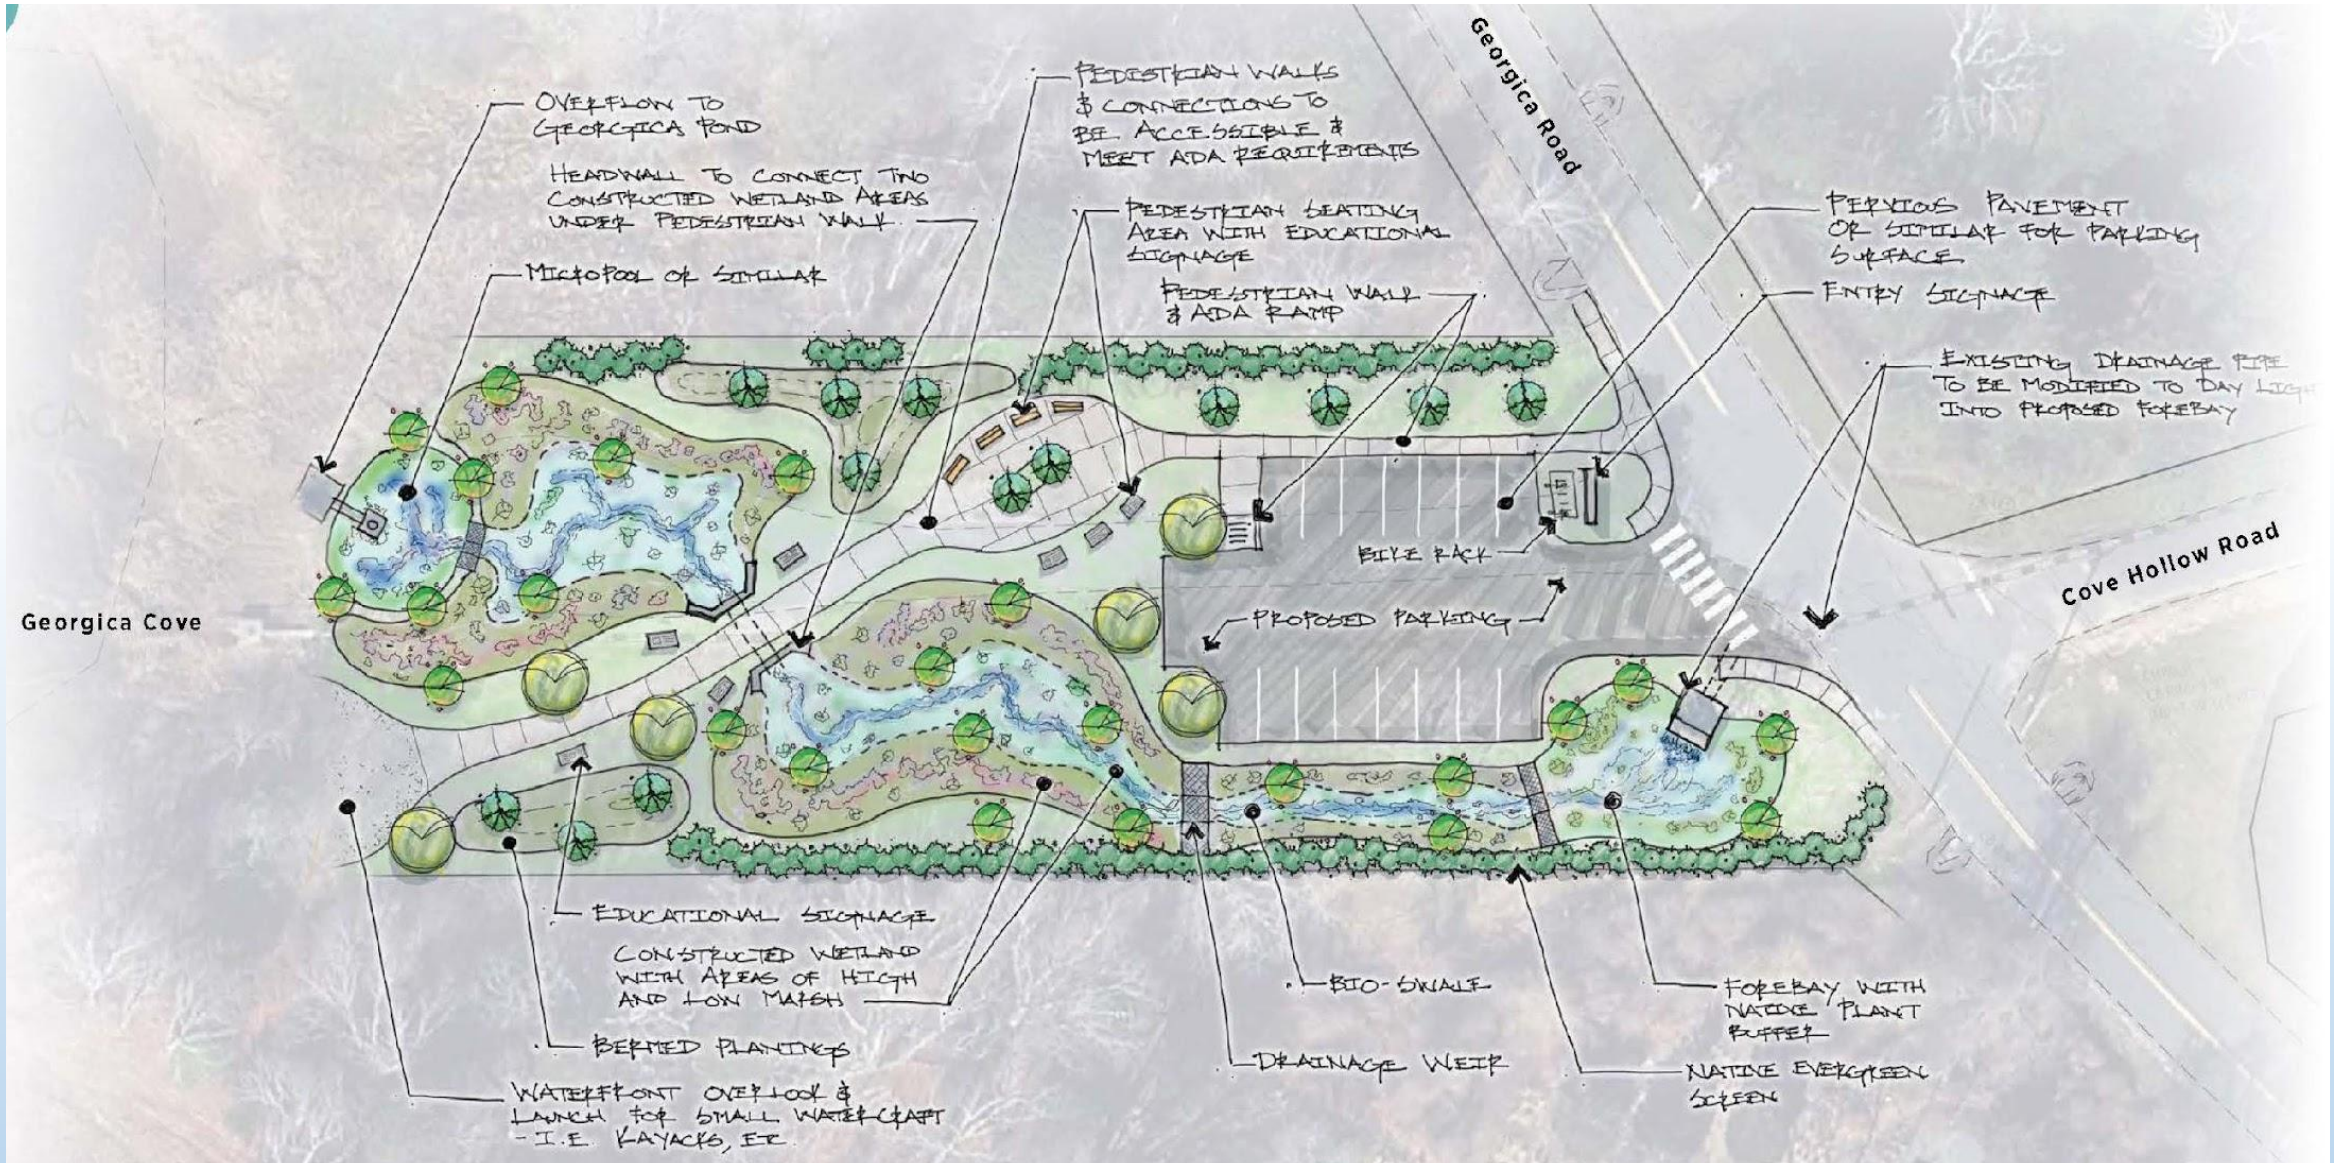
# Cove Hollow: End of Pipe Treatment

## Conceptual Design

- Install drainage inlet filters and clean-out catch basins on all structures
- Establish standard specifications for drainage structures for ease of maintenance
- Repair damages to pipe and inlets/fix deficiencies identified
- Capture runoff in upland to reduce volume of water entering pipe and conveyed to Georgica Cove
  - Install additional drainage structures in targeted areas to reduce ponding
  - Explore feasibility of purchasing open parcels or leasing property along corridor for drainage storage and treatment
- Reconnect recharge basin on north side of NY114 in vicinity of Cove Hollow Rd
- End of pipe treatment: relocate drainage system outfall and create a constructed wetland treatment system into the Cove with forebay and micropool

- Comments from TOEH, Trustees, Village and FOGP kick-off meeting with VHB;
  - Maintain vehicular/emergency access to the Pond at Georgica Cove
  - Improve/allow for kayak access to the Pond
  - Maintain viewshed of the Pond
    - Arrange parking to allow for front in parking or views for quick stops
  - No lighting
  - Remove sidewalks near entrance
    - No sidewalks along Georgica Road to connect to
  - Reduce parking area
  - Protect existing native vegetation

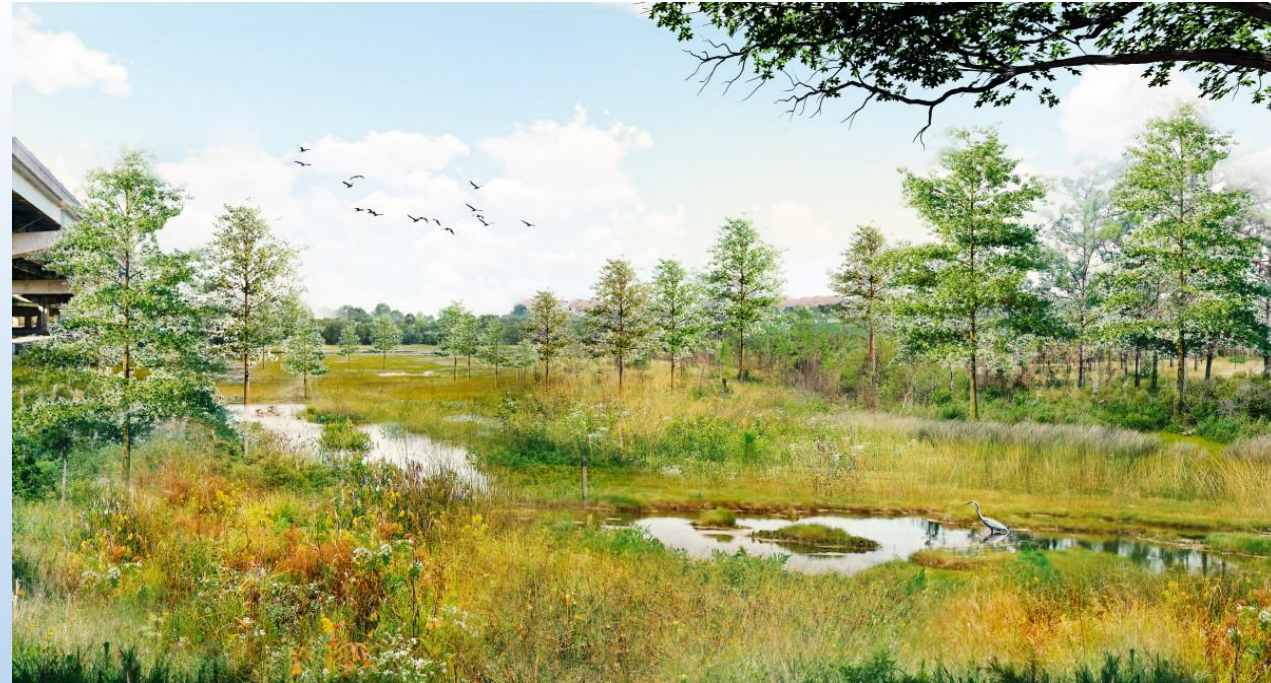
# Cove Hollow: End of Pipe Treatment

## Conceptual Design
