# Sustainable Remediation of Georgica Pond

**Christopher J. Gobler, PhD**

Stony Brook University  
*School of Marine and  
Atmospheric Sciences*

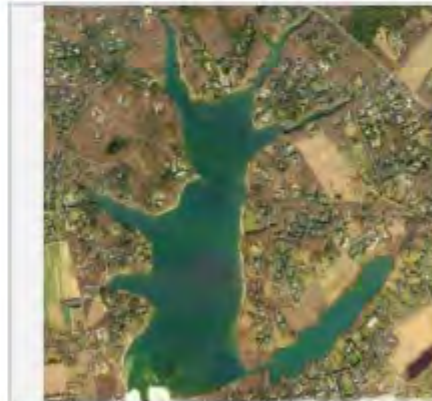
As part of The Georgica Pond Project, the Gobler laboratory has installed a water quality monitoring buoy in Georgica Pond. This device is making continuous, real-time measurements of key water quality indicators that are instantly telemetered to this web site.

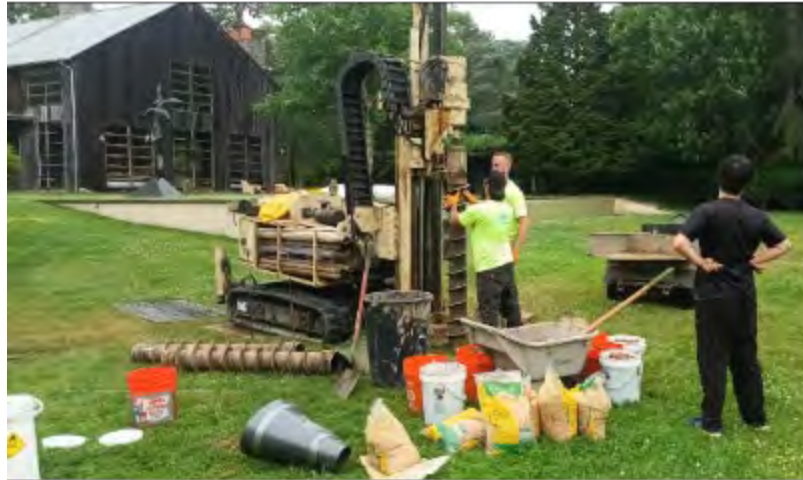
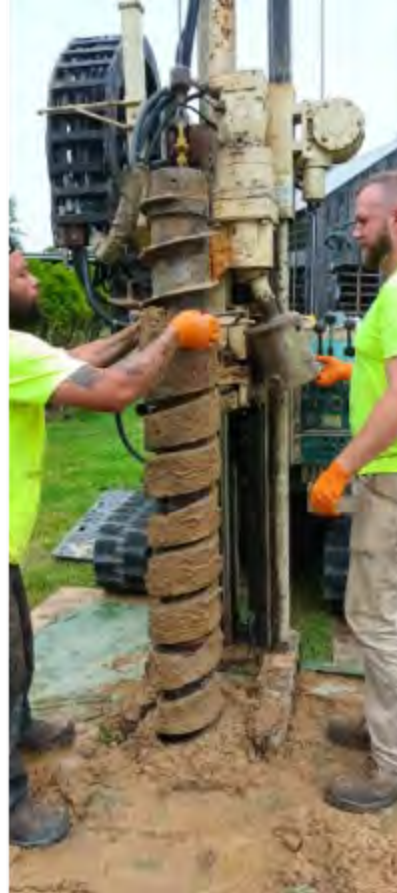
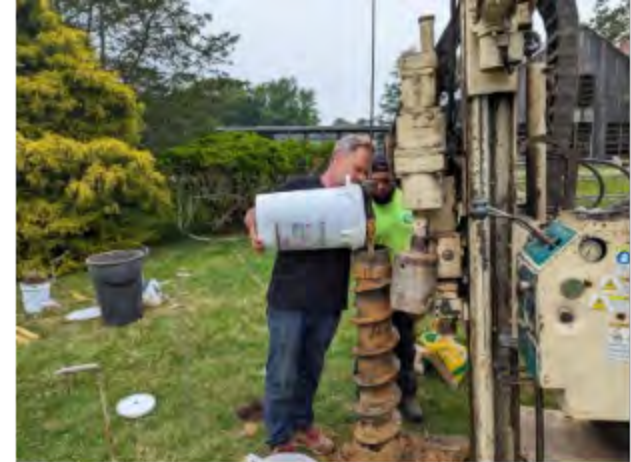
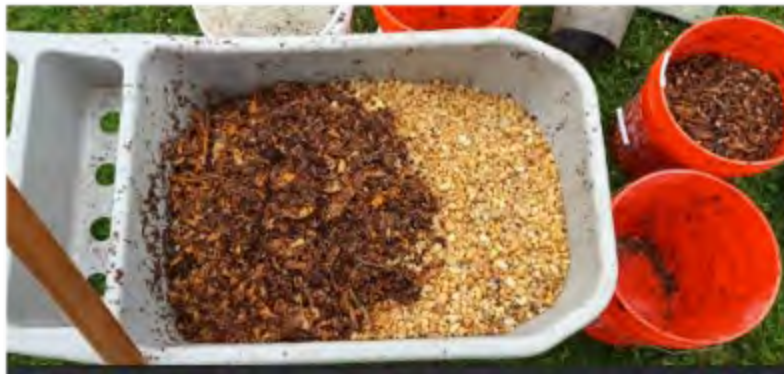
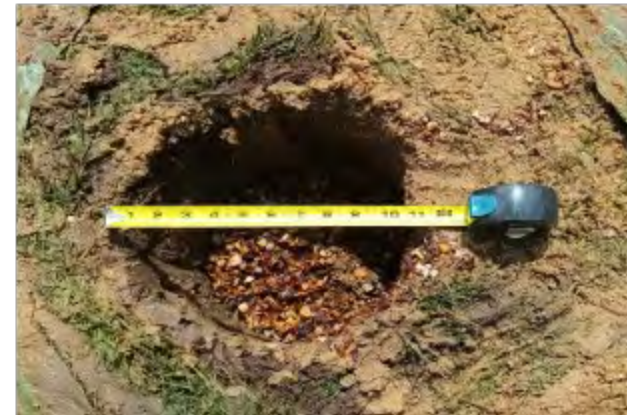
# Carbon array installation at The Creeks, Georgica Pond

- Nitrate completely removed in the center of woodchip columns
- Lower nitrate concentrations downstream
- Matches model simulation

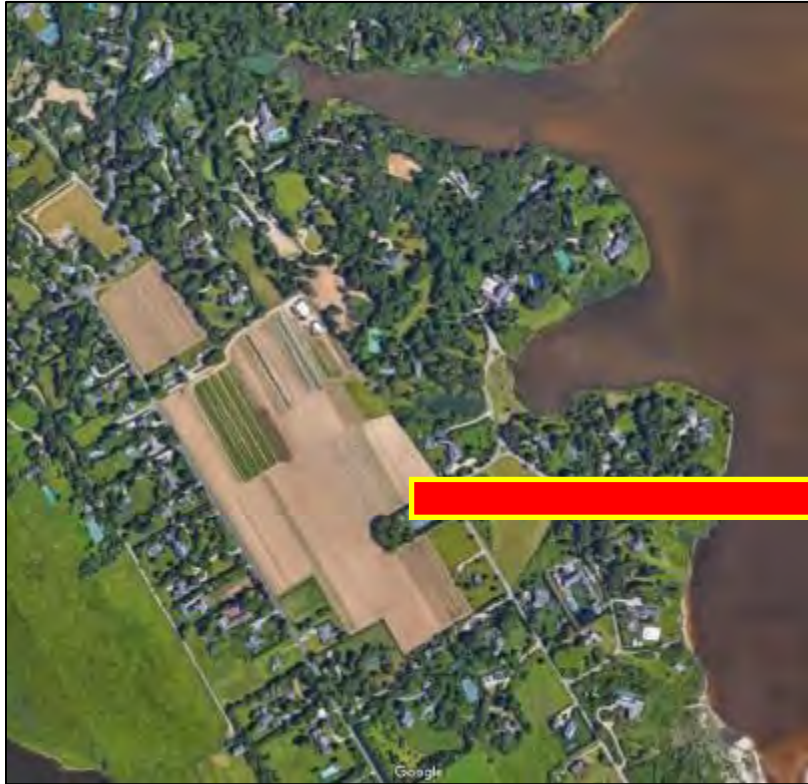
# High nitrate plume entering Eel Cove

- These are the highest groundwater N levels ever measured in in East Hampton Town.
- CCWT seeking to submit a grant application to the Town of East Hampton CPF fund for a PRB to remediate this N source.

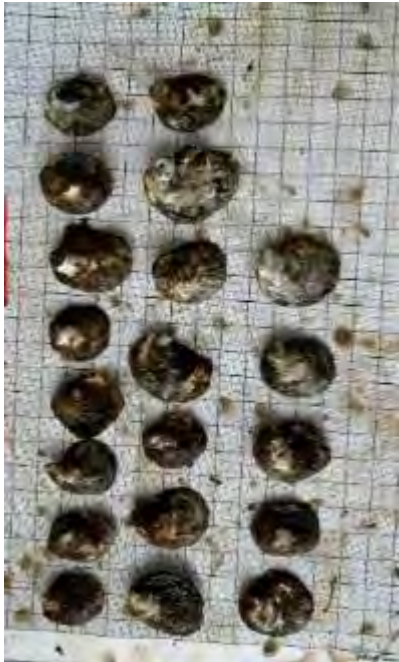
Single-set seed

- Initial experiments conducted to map oyster survivorship, growth, and disease across Georgica Pond
- Oysters placed in cages at three study sites (North, Central, South)
  - **Single-seed oyster seed deployed in 2019**
  - **Spat-on-shell deployed in 2021**

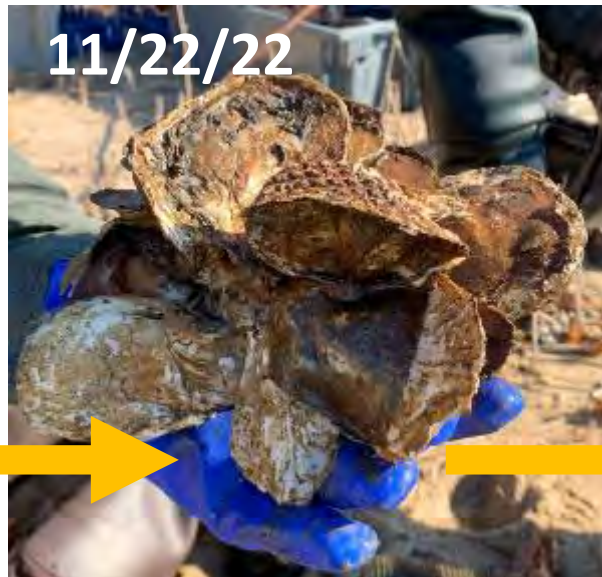
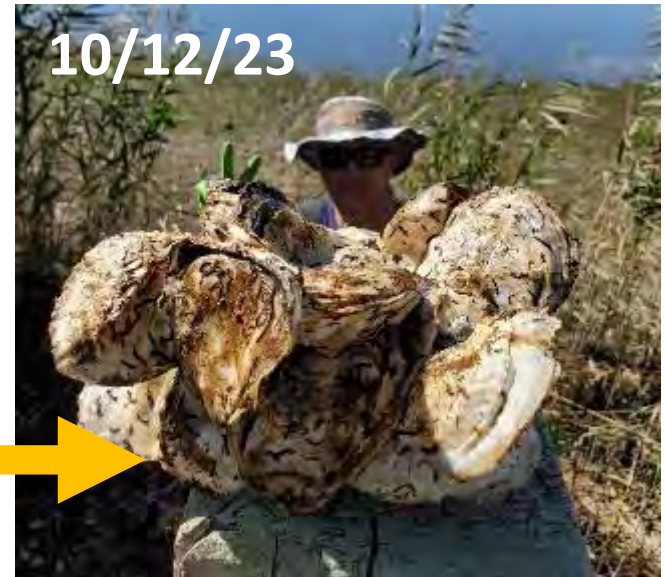
Growth

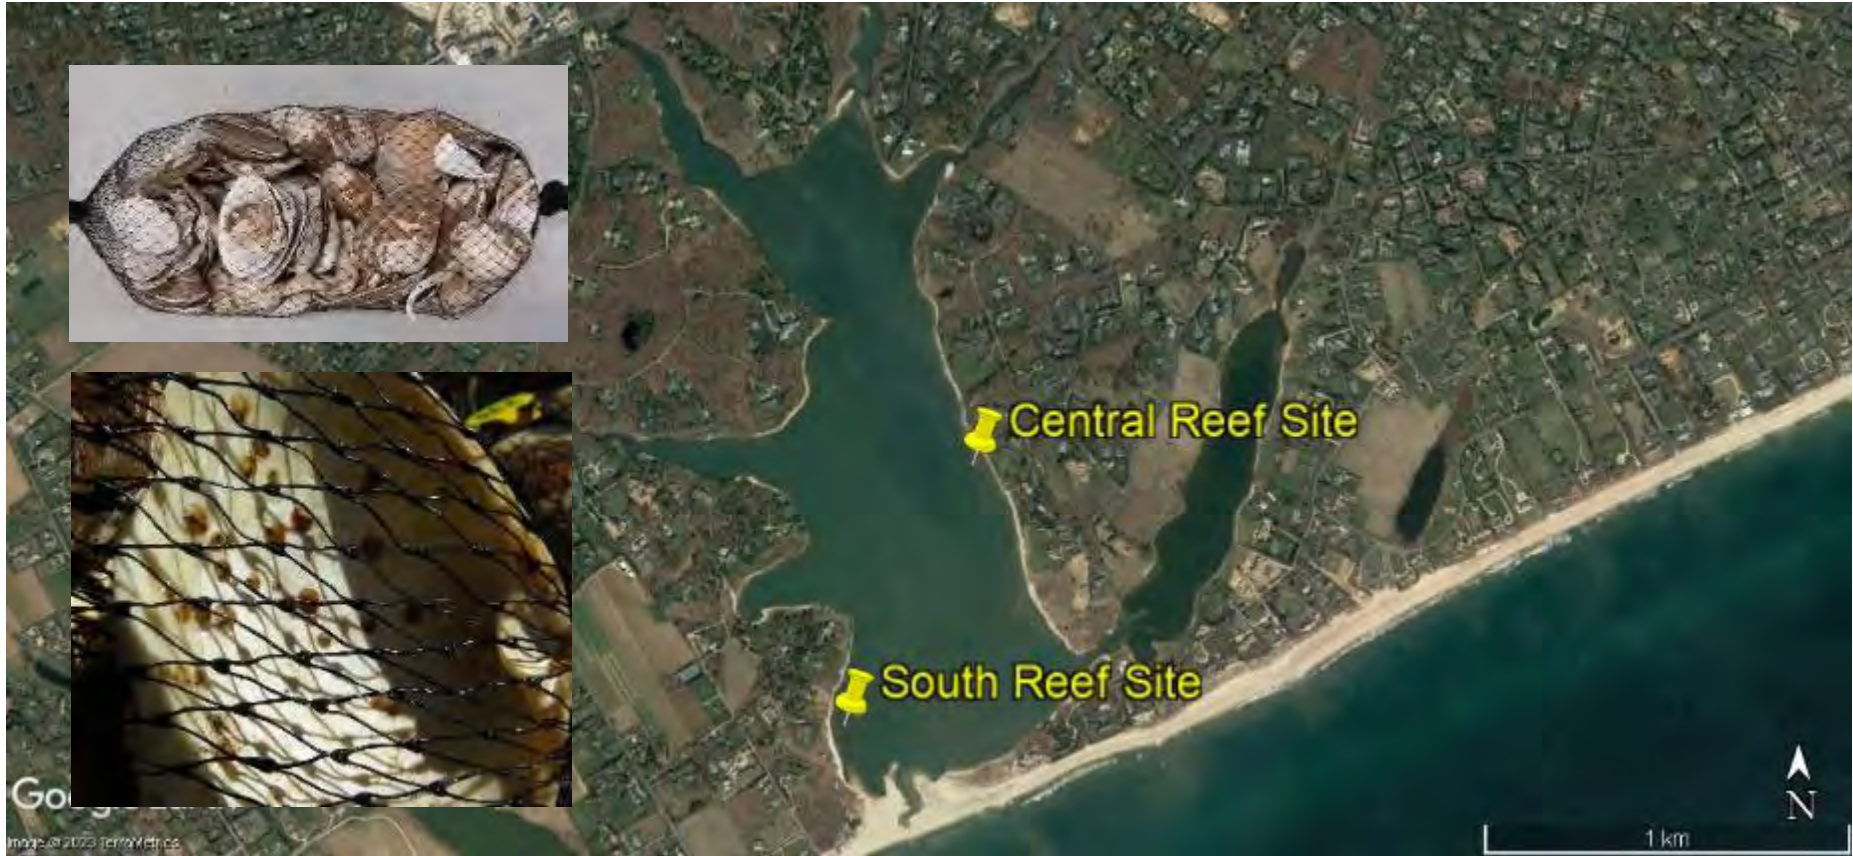
## Pilot Oyster Reefs

- Installed small test oyster reefs at two sites (central and south) in fall 2022
- Reefs constructed using shell bags containing oyster spat-on-shell

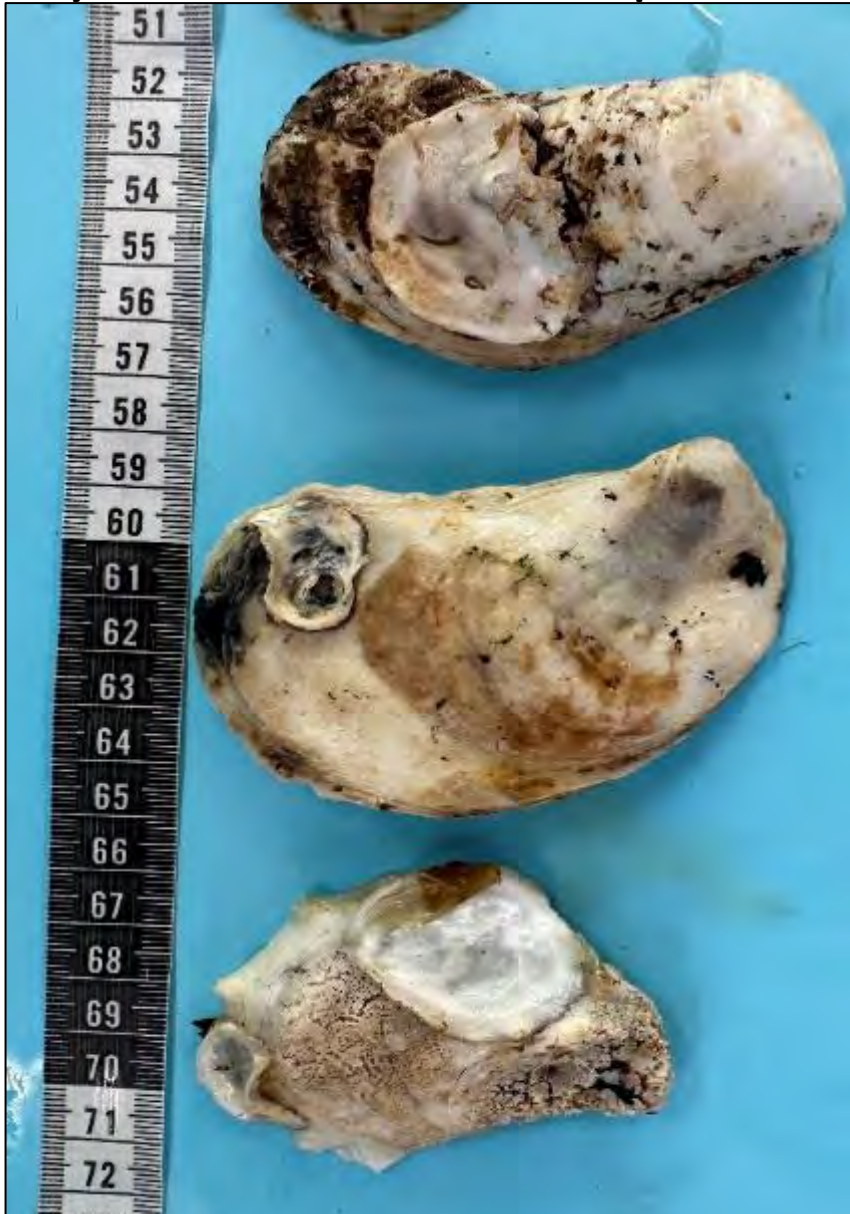
Oyster scars: Evidence of crab predation

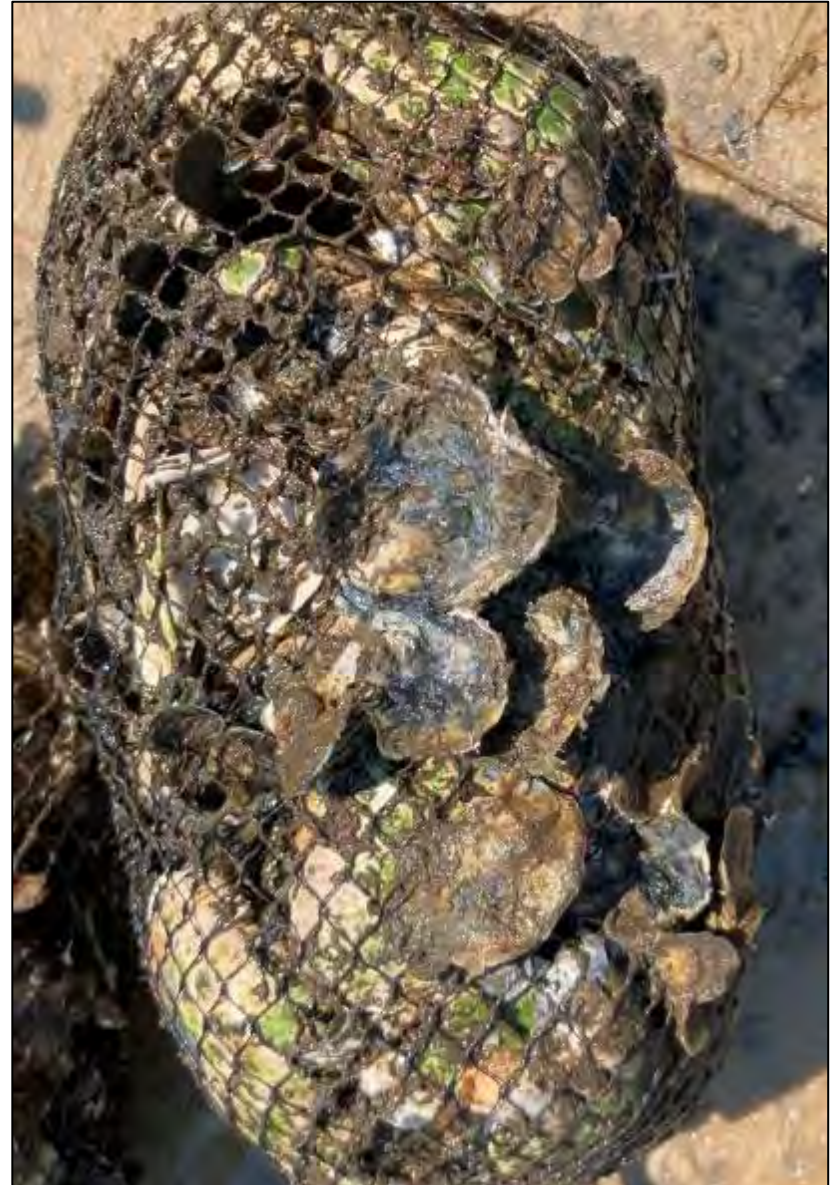
Two-year old shell bag, emergent oysters
